Manhole Inspection Summary

Manhole # S43M__014MH

Location Address: **904 broadway st**

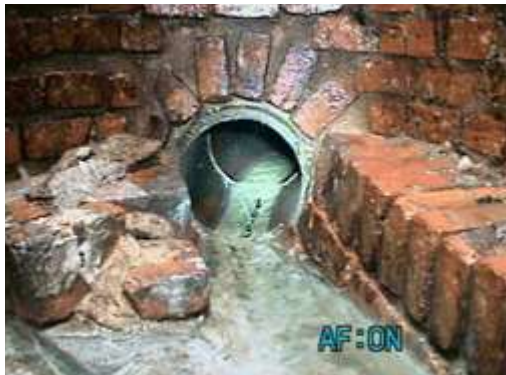
Defect 3

Condition: ☐ Sound ☐ Cracked ☐ Root Intrusion ☒ Deteriorated ☐ Leaks ☐ Debris

bench deteriorated

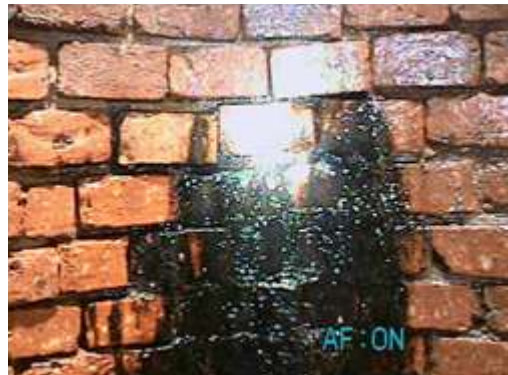
Defect 1

Infiltration: ☐ None ☐ Joint ☐ Cracks ☐ Mortar ☐ Roots ☒ Wall

infiltration at barrel wall

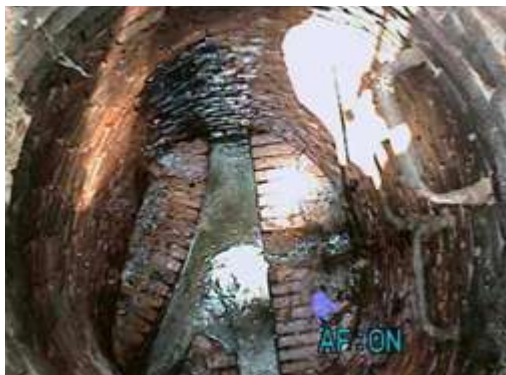
Defect 2

Steps Count: **6** Missing: **2** ☒ Corroded

Surcharge ☒ Evidence Of Surcharge Depth: **5** (ft.) ☐ Active Surcharge Present

missing/corroded steps, surcharge evidence

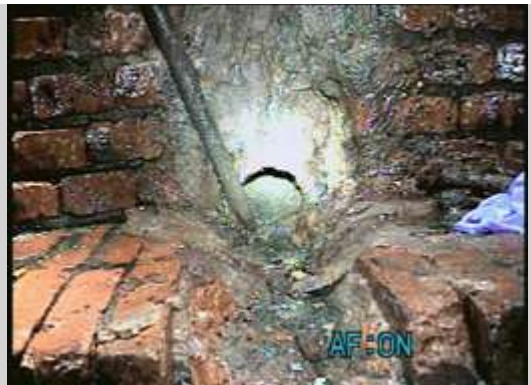
3 O'Clock Inflow

10 in. Circular Gravity Sewer
Pipe In @ 3 O'Clock

Deposits: ☐ None ☐ Mud ☐ Sludge ☒ **Debris** ☐ Grease

Silt Depth: 0 (in.) Deposits Extent: **Medium**
